Herdt Home Inspections

Date of Inspection: January 28, 2025

Inspection #: XXXX

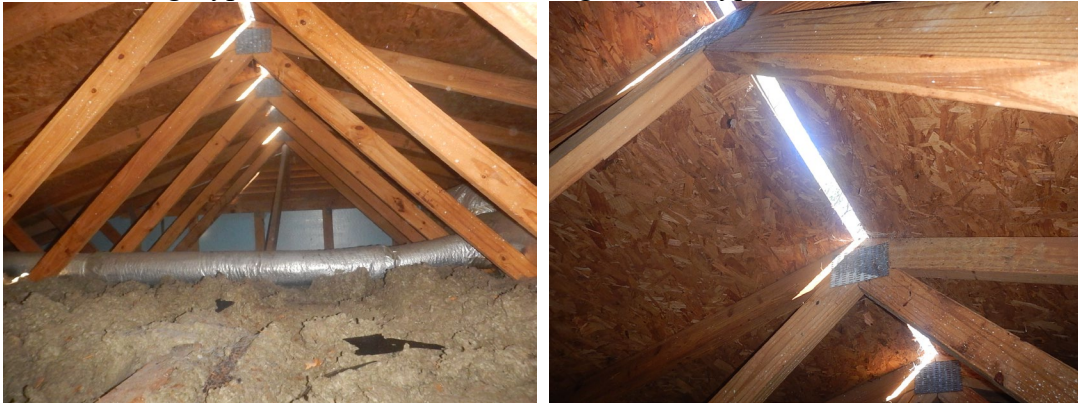
Example of manufactured truss framing and slot cut in ridge of roof to allow for installation of ridge vents

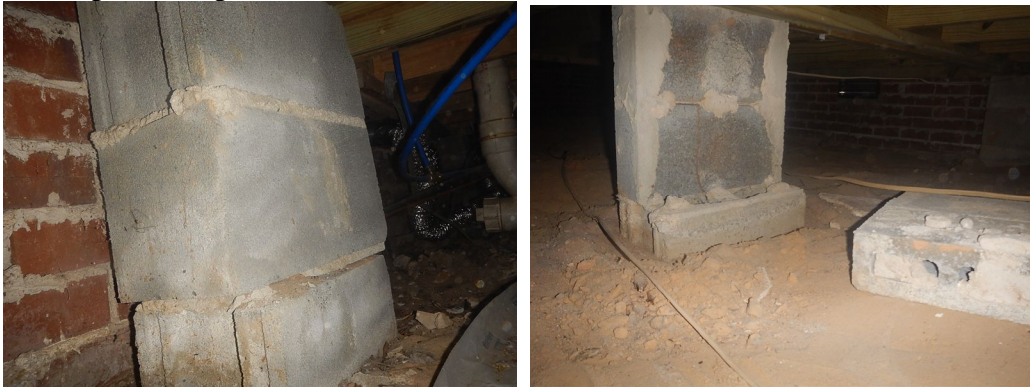
Piers sound/comments: Original piers are generally sound. **However, some damage to masonry has occurred during floor system reconstruction with repair by a licensed contractor needed. All piers should be evaluated during repairs as some have less severe damage than pictured piers.**

Pier (left) immediately inside access opening has broken mortar joint with upper section tilted off vertical. Pier under living room (right) is broken in half.

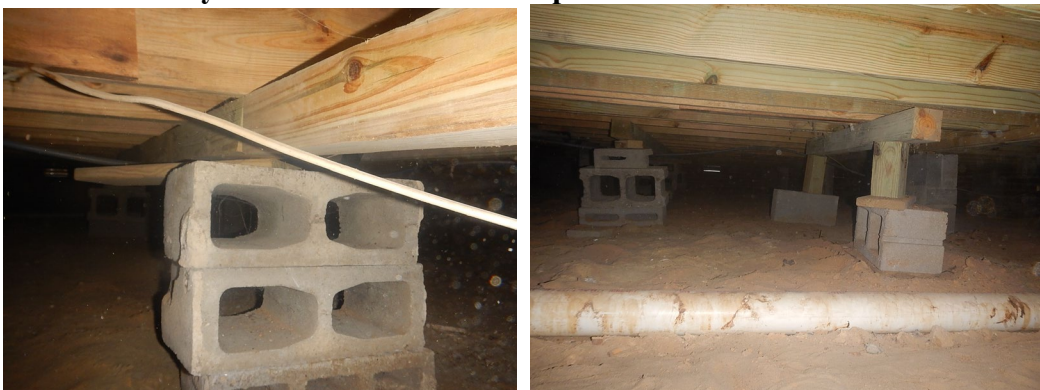
Numerous auxiliary piers have been installed to support drop sills (4x4 members) and splices of scabbed floor joists. **Virtually all of these are not properly constructed and should be corrected by a licensed contractor to prevent failure.**

Improperly oriented (horizontal rather than correct vertical) orientation of cells makes blocks subject to failure. Short wood “Stiff Knees” are not stable supports (right). Also note scabbed floor joist repair (left) that can fail if not properly supported.

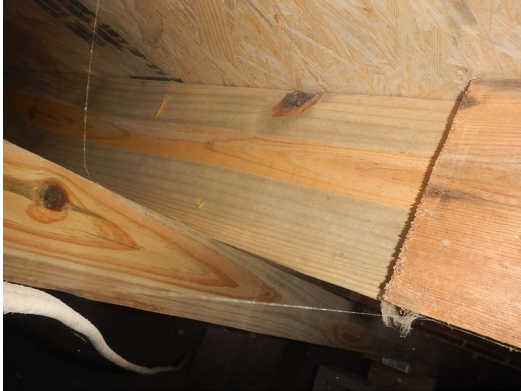
Joisting condition: A very large percentage of floor joists have been replaced (apparently due to old termite infestation and/or rot damage). Wood members are new and are sound overall. Most joisting is properly installed (running from perimeter sills to center sills in an unbroken run). **However, some of original joisting that was cut during repairs have been scabbed by adding short pieces that are either not supported at splice or have inadequate support as noted in Pier comments. See Sill comments that follow.**

Example of scabbed repair with 4x4 support. Slight sagging has already occurred

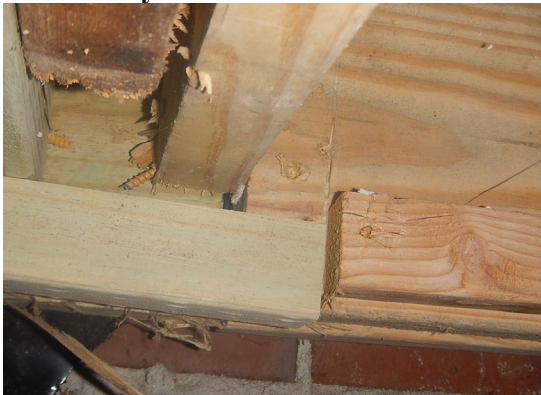
Sill Problems or other concerns: **Much of perimeter band and interior/center sill wood has been replaced with new wood. Wood itself is sound but is not properly supported in some areas as noted in Pier comments.**

Some areas where new wood meets old have sagged, or were installed out of line, with correction by a licensed contractor needed.

Example of sagging/misaligned butt jointed sills. Also note tan color decking screw used to toenail floor joist to sill

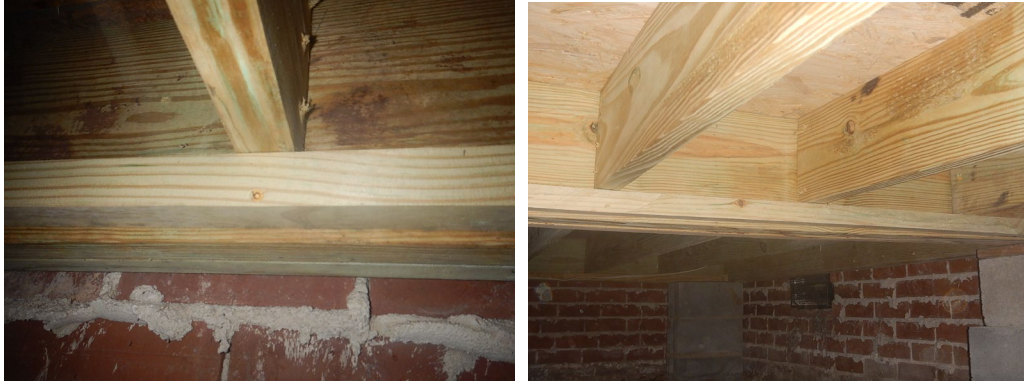
Ledger support boards (2x2 secured to lower edge of sills to support floor joisting) are not properly secured to sills and will tend to separate from sills when furniture/live loads are applied to floor system.

Ledger (left) with on screw under joist and toe-nailing visible. Random (right) spacing of tan color nails (hard to see screw heads in wood)

Correct nailing calls for one nail directly under each floor joist and one nail to either side of each floor joist. In the case of ledger boards installed during floor system repairs this nailing schedule was not followed. Some ledger boards have decking screws installed every 12-16 inches, some have screws installed every 3-4 feet and others have random spacing. Correction by a licensed contractor is needed to prevent failure.

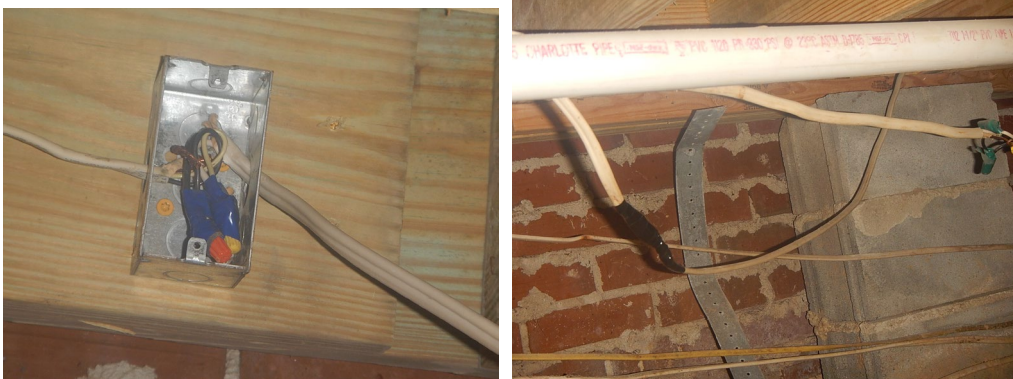
Seismic Control Straps in place? **Some in place but not reattached to wood members during repairs.** *See picture following Sill comments.*

There are hazardous wiring connections in crawl space that should be corrected by a licensed contractor.

All line splices, wiring connections and abandoned wires should be enclosed in covered junction boxes. Also note metal seismic/wind lift control strap (right) that has not been attached to new wood of sill above.

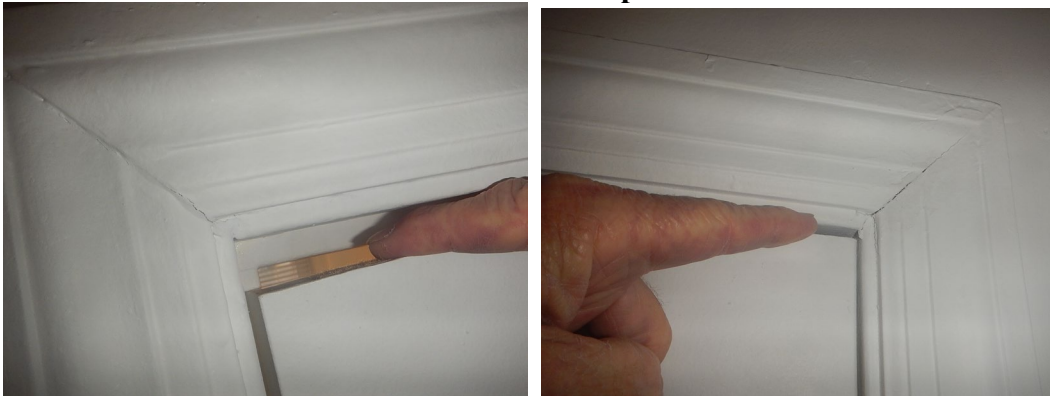
Door from bedroom into bathroom has out of square door frame/casing. Door drags on floor and correction is needed for normal operation.

Latch side of door (left) has large gap at top when closed and hinge side (right) has normal gap

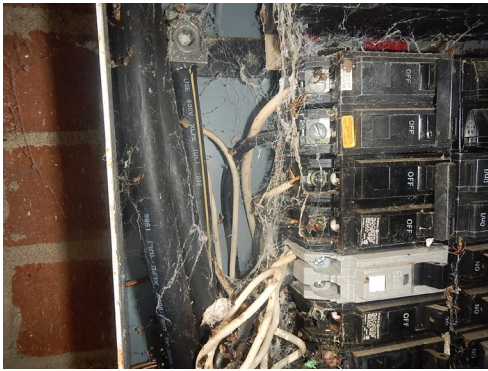
Correct division of circuits: correct. **However, there is a large volume of insect debris (webs, casings, etc.) inside panel box that should be removed by a licensed electrician.**

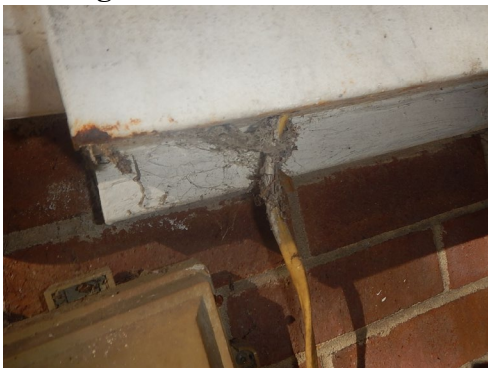
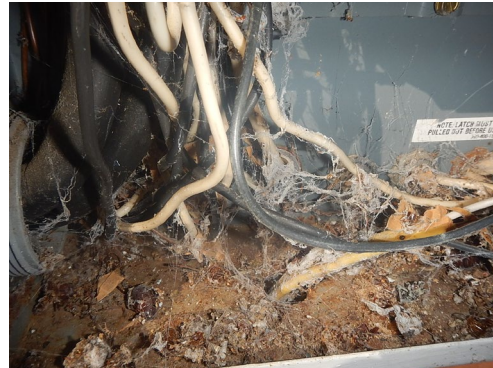
Correct line sizes for protection installed: correct. **However, Type NM wire that runs through knock out at bottom of box is not rated for sunlight/UV exposure or for wet areas. Enclosing wire in conduit and installing grommet in knock out/pass through is needed to prevent damage to wire insulation.**

Type NM wire (left) is darkened from exposure to UV and damp while wire pass through (right) lacks a grommet to prevent insect entry and damage to wire insulation

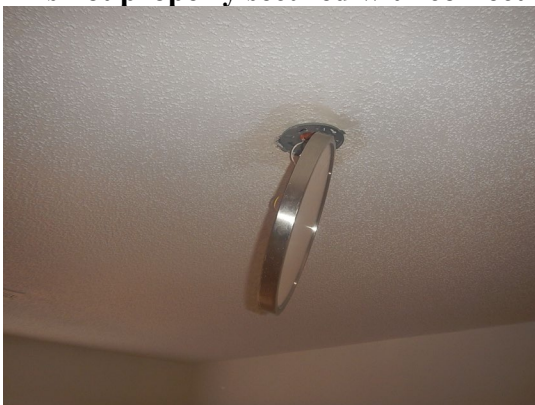
Ceiling Fans Functional: None installed. **Ceiling light fixture in west/master bedroom is not properly secured with correction needed.**

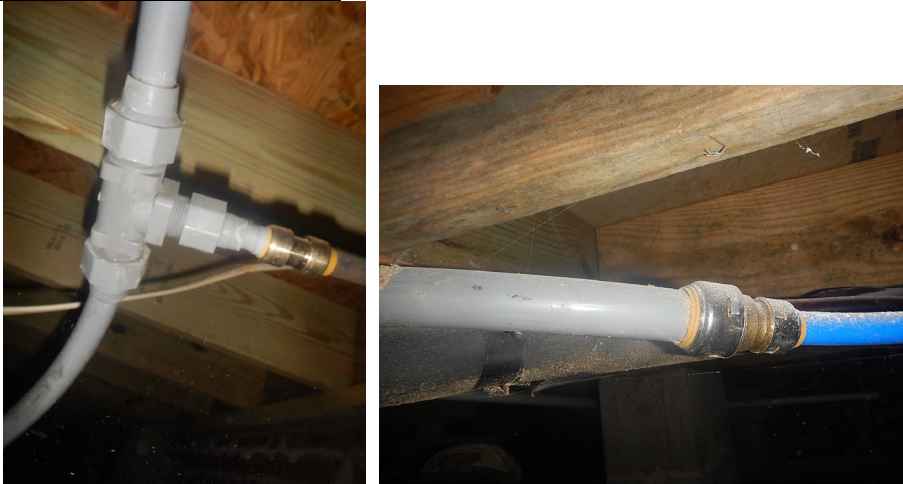
Supply line material: PEX flexible line has been installed during renovations. However, some of original polybutylene supply line with nylon fittings remains in place under house. *This type of system has been the focus of litigation and class action settlements. There is no evidence of any current failure of system at this residence and I am not aware of any problems relating to this type of system in this area. However, I recommend that seller provide any available information to assure protection of any rights that may have been assigned to this residence. Replacement of this pipe (apparently runs from utility meter to house) is strongly recommended.*

Examples of polybutylene gray pipe and connection to blue PEX cold water line

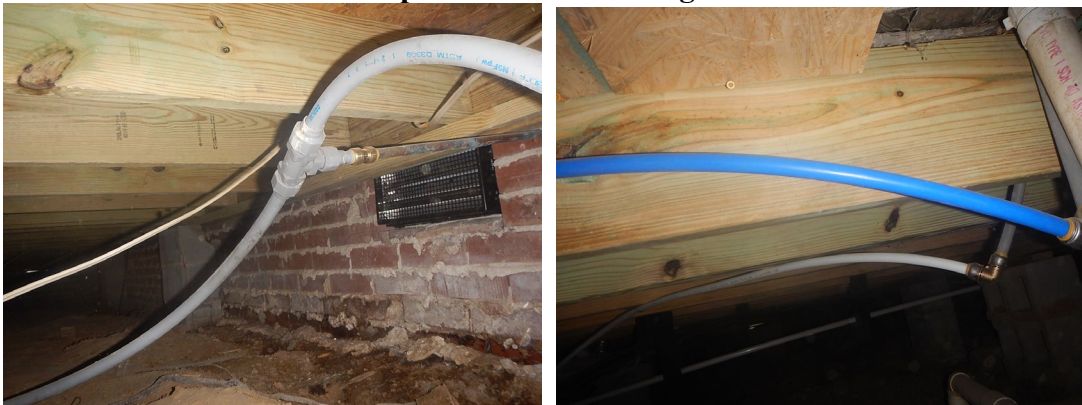
Newly installed PEX and other supply lines under house and in unheated utility room are not insulated as needed to prevent freeze damage.

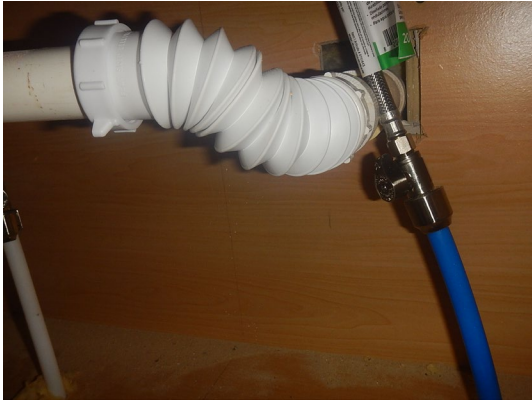
Ribbed/flexible drain line installed at kitchen sink will tend to clog. Replacement with smooth section of PVC is recommended.

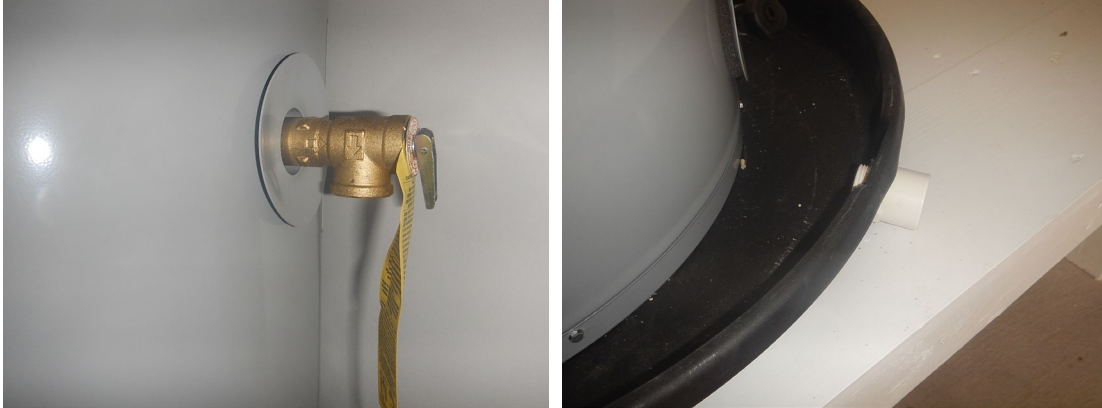
Pressure relief valve installed and properly vented to exterior or floor: **Valve is in place but is not piped to exterior as needed to prevent scalding and/or damage**

Leak pan installed as needed/recommended: pan is in place **but does not have a drain line installed to direct leaks to exterior (concrete floor at this area and any leaks would cause minimal damage).**

Brass TPR valve will vent steam and hot water into utility room if activated (left) and white fitting on leak pan (right) should have pipe connected to drain water to exterior in event of a tank leak.
